# FACILITY COMPLIANCE INSPECTION REPORT

Anna Wink LCID Landfill  
 Anna Wink Road  
 Newport, NC 28570

N0655-20120911NOV

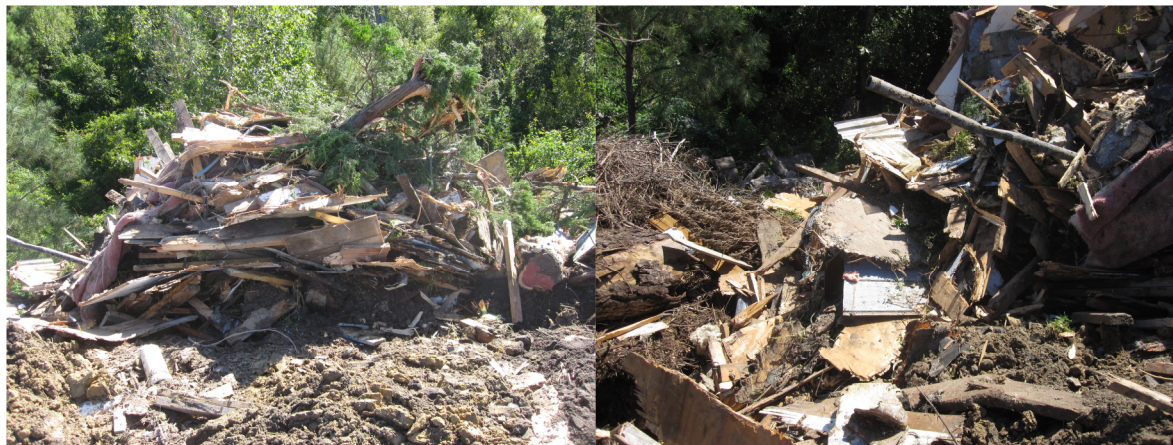
- 1) 15 NCAC 13B .0566 OPERATIONAL REQUIREMENTS FOR LAND CLEARING AND INERT DEBRIS (LCID) LANDFILLS (2) The facility shall only accept those solid wastes which it is permitted to receive.**  
 You are in violation in that: you have received for disposal Construction & Demolition (C&D) wastes consisting of vinyl siding, plywood, painted wood, treated lumber, insulation, carpet, flooring, and pvc pipe.  
**\*Within thirty days of this Inspection: Remove all unpermitted materials and transport them to a Facility permitted to receive such wastes. The closest Facility permitted to receive such wastes is the Coastal Environmental Partnership Solid Waste Transfer Station, permit #16-05T located on Hibbs Road in Newport. Please save copies of all weigh tickets for proof of proper disposal.**

Unpermitted C&D waste disposed at the LCID Landfill Notification
